Measuring water penetration

A simple, inexpensive tube test can yield valuable, quantitative information

by Kim Basham and John Meredith

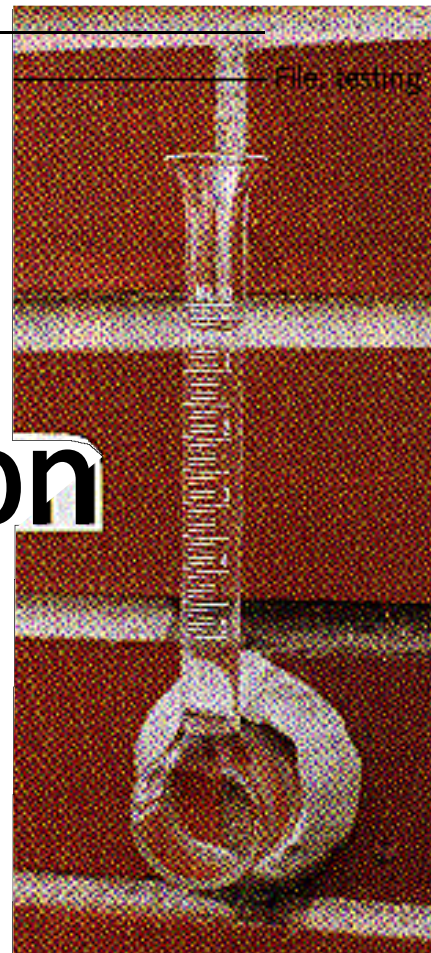
RILEM or MAT tubes are pipelike devices. The tube or stem portion is graduated from 0.0 to 5.0 ml. The volume of water absorbed over a specified time is read from this graduation.

The photo on the next page illustrates the pipelike MAT tube used to test vertical surfaces. Similar tubes are available for testing horizontal surfaces. Made of either plastic or glass, the tube has a flat, circular brim at the bottom which is attached to the masonry surface with soft putty. The test area is small: only 1 square inch. The tube, which holds 5 milliliters (or 0.2 fluid ounces) of water, is graduated in 0.1-milliliter increments from 0.0 to 5.0 ml, making estimates to the nearest 0.05 ml possible.

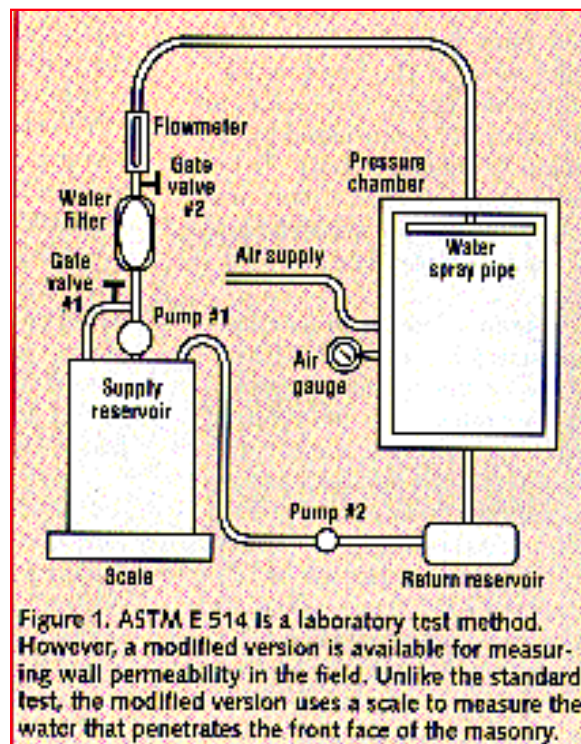
Figure 1. ASTM E 514 is a laboratory test method. However, a modified version is available for measuring wall permeability in the field. Unlike the standard test, the modified version uses a scale to measure the water that penetrates the front face of the masonry.

There also is a version of the ASTM E 514 test modified for field testing, for which neither flashing nor access to the back of the wall is necessary. The field version measures only the amount of water passing through the front wall face. Figure 1 illustrates an ASTM E 514 equipment layout for field testing. The scale measures the amount of water that has penetrated through the front face of the masonry.

The field version includes a ½-hour preconditioning period (to saturate the wall with water) followed by a 4- to 8-hour testing period. Water is supplied from a calibrated tank and returned to the tank from the bottom of the chamber.

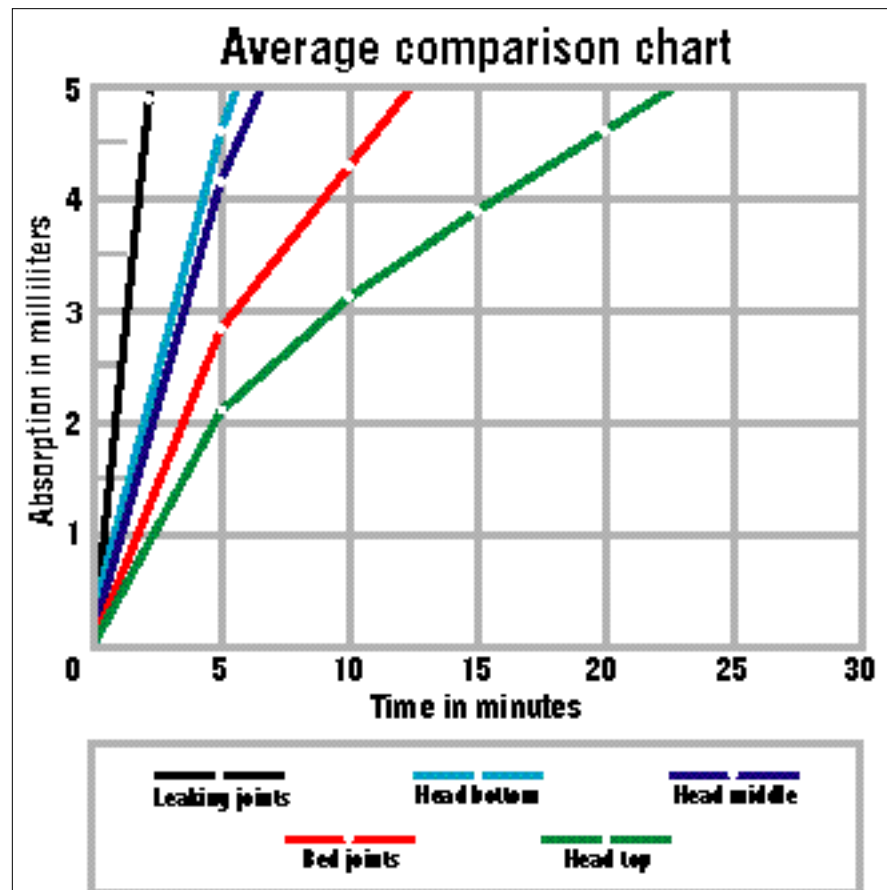
Figure 2. Absorption graphs show the volume of water absorbed in milliliters versus time. The more permeable the masonry, the faster 5 ml of water will be absorbed.

- Furrowing bed joint mortar increases water penetration at the bed joint. Figure 2 graphically shows a comparison of average absorption values for the different joint locations.
- Joints that absorb 5 ml of water in 5 minutes or less are most likely to leak water through the wall, while joints requiring 15 to 25 minutes to absorb 5 ml of water show no signs of leakage or wetting patterns on the back of the wall (Ref. 4).

5. Interpret test results. Depending on the number of readings, plot test results for each test location on a graph showing water absorption versus time (see Figure 2). Compare results (i.e., weathered versus unweathered, treated versus untreated, head joints versus bed joints, etc.). If a joint absorbs 5 ml of water in 5 minutes or less, most likely it is a leaky joint. If mean weathered test values are about twice the mean unweathered values, weathering is a concern.
